World News of Natural Sciences

Environmental Flood Protection Dikes

Tomas U. Ganiron Jr.

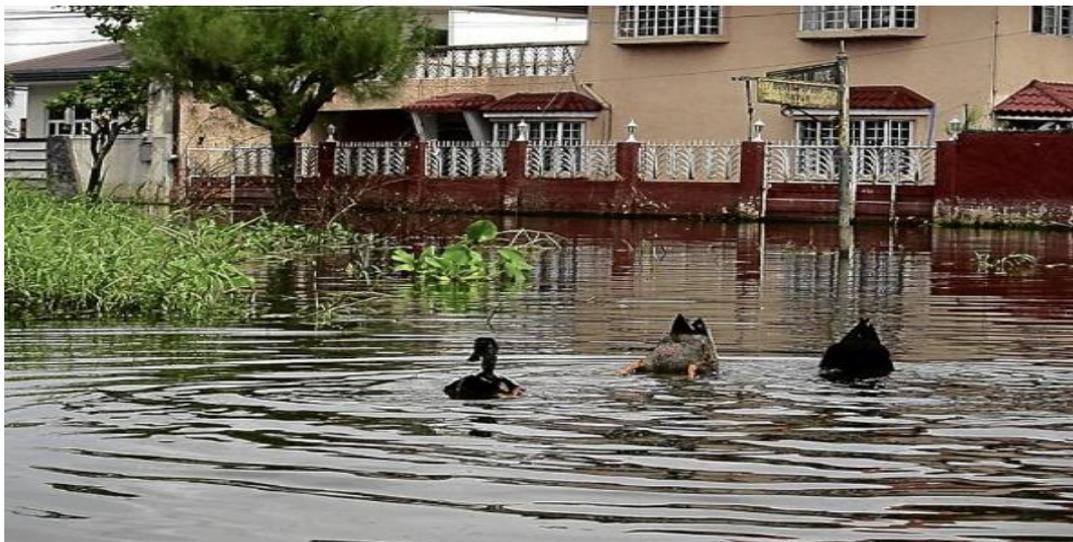
Figure 1. Floods in Bay Breeze Executive Village in Barangay Hagonoy, Taguig City

Since the front door entrance is underwater, residents now climb ladders leading to a second-floor window to get in.

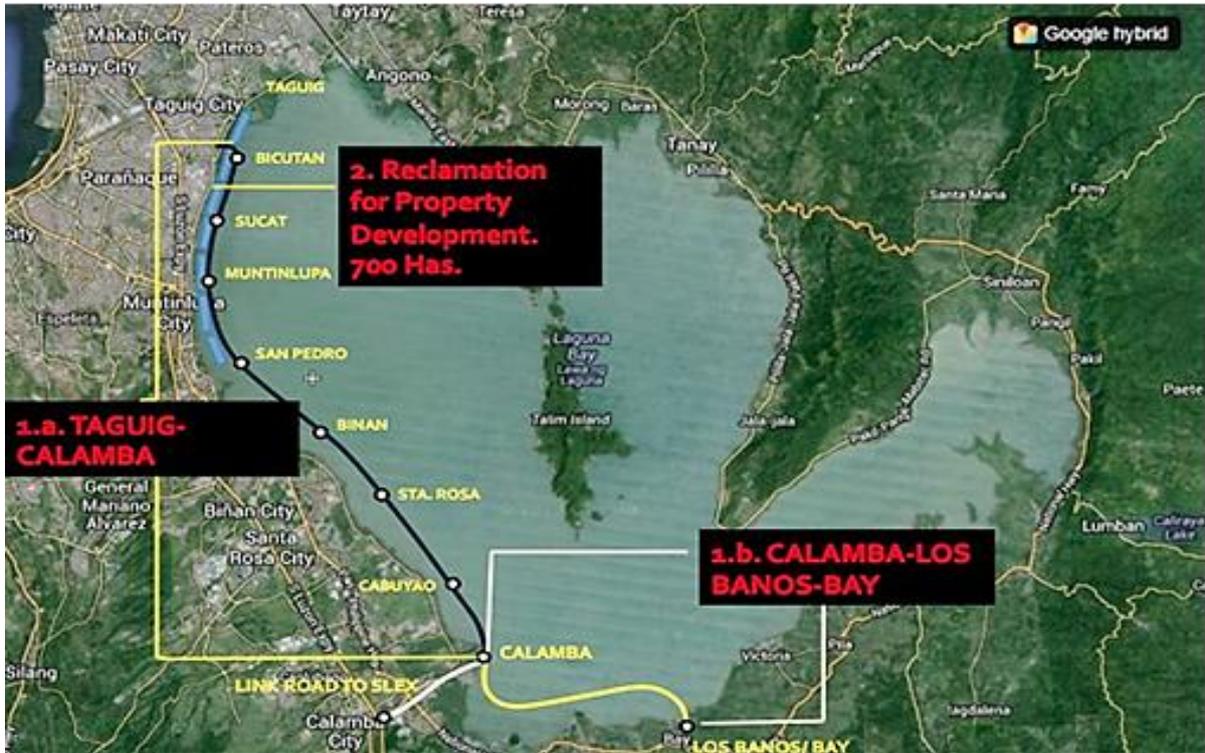
Figure 2. Project map of Laguna Lakeshore Expressway Dike

As shown in Figure 2, the route alignment starts from Bicutan, Taguig connecting to the proposed C-6 Expressway Road Project. It traverses southwards passing the city boundaries of Taguig, Parañaque, and Muntinlupa in the southern part of Metro Manila and then continues further south passing the cities of San Pedro, Biñan, Santa Rosa, Cabuyao, Calamba and ends up at Los Baños in Laguna, near its boundary with Bay. The construction of the expressway dike is proposed to involve two sections. These are from Bicutan to Calamba, and from Calamba to Los Baños.
